# TESTING OF POLYIMIDE SECOND-STAGE ROD SEALS FOR SINGLE-STATE APPLICATIONS IN ADVANCED AIRCRAFT HYDRAULIC SYSTEMS

by A. W. Waterman

May 1977

Boeing Commercial Airplane Company  
P.O. Box 3707  
Seattle, Washington 98124

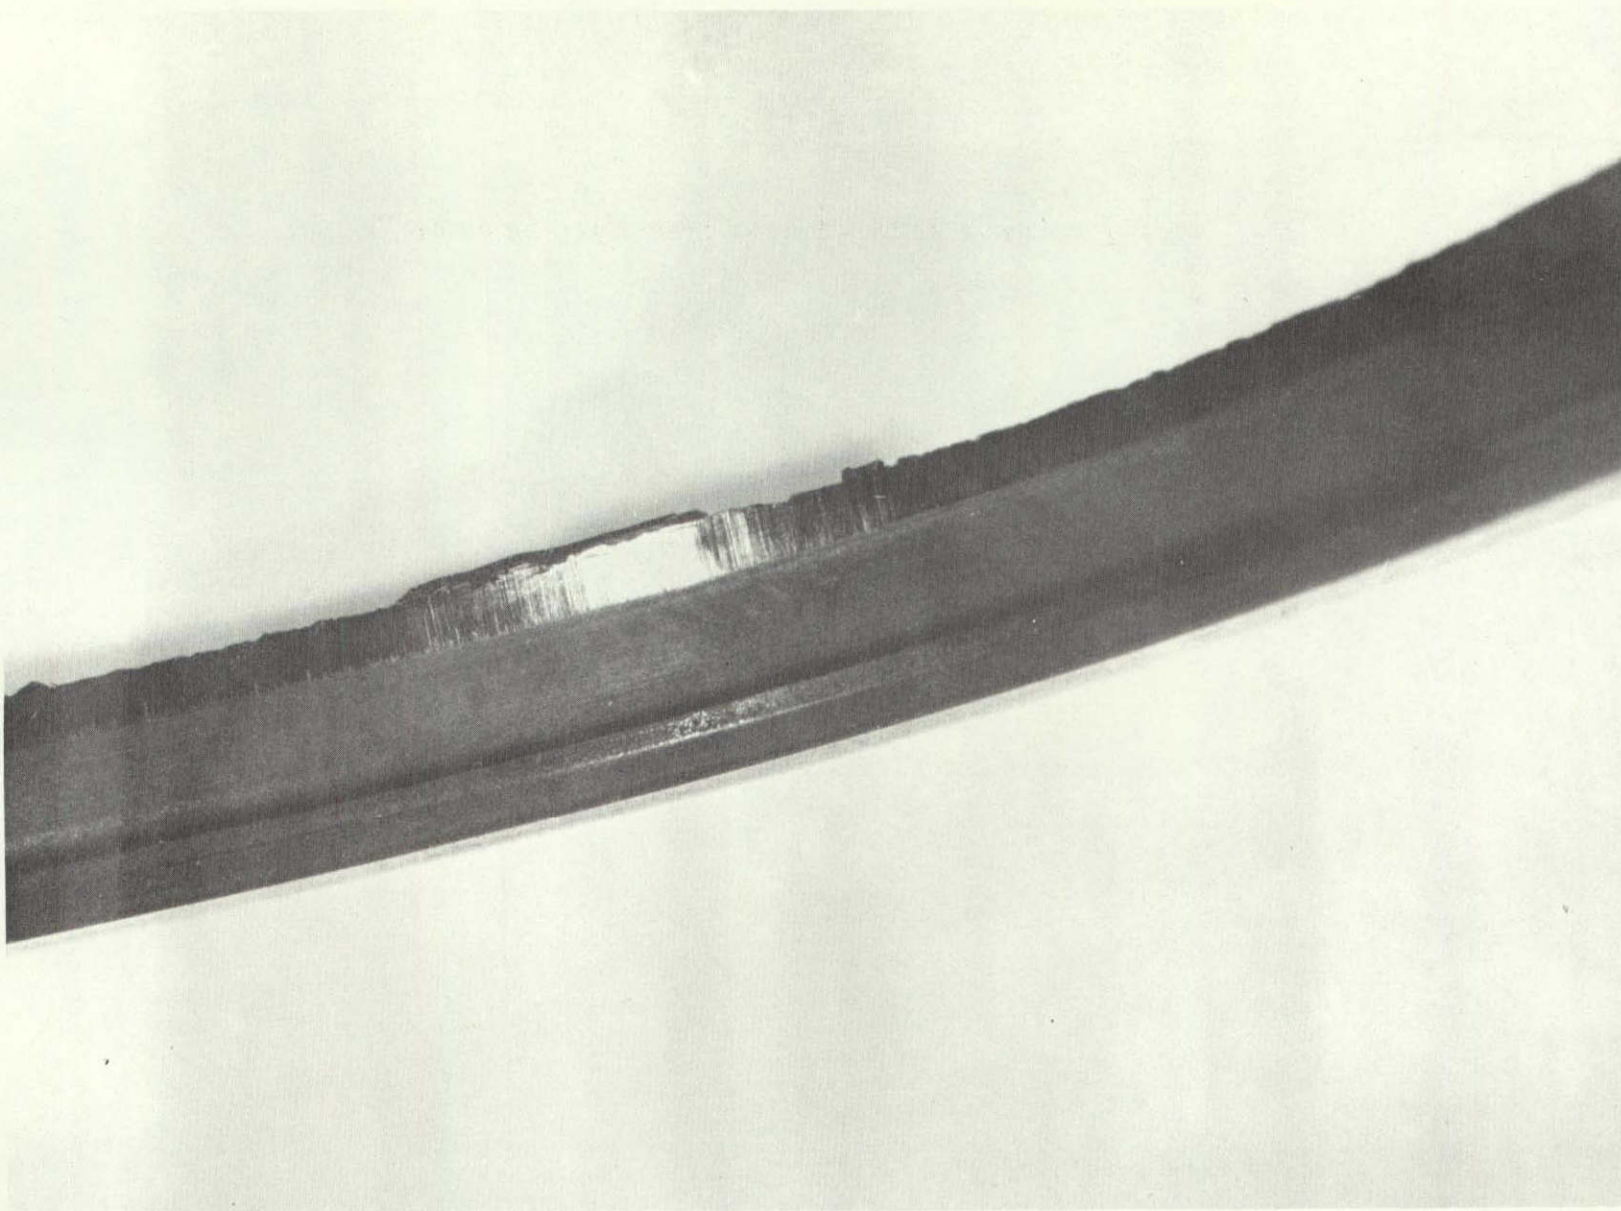
Figure 19.—Downstream Element, Inside Diameter Sealing Edge Wear
